EVALUATION REPORT 827

24 JANUARRO 1958

EVALUATION OF BATHYTHERMOGRAPH MODELS OC-1C/S AND OC-2C/S.

U. S. NAVY ELECTRONICS LABORATORY, SAN DIEGO, CALIFORNIA A BUREAU OF SHIPS LABORATORY

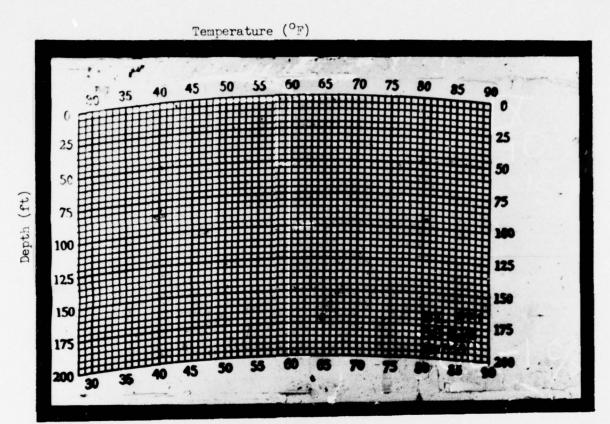
Figure 1. PP-1 Calibration trace.

1. The layout of both the PP-1 and PP-2 grids is good. However, the PP-1 (fig. 1) must be considered unacceptable because the lines, which vary in width from 0.0025 to 0.0045 inch, are much too wide for reading to 0.1°F. The calibration trace is nearly hidden. Wide grid lines can be caused by wide harp lines, shadows, or overexposure.

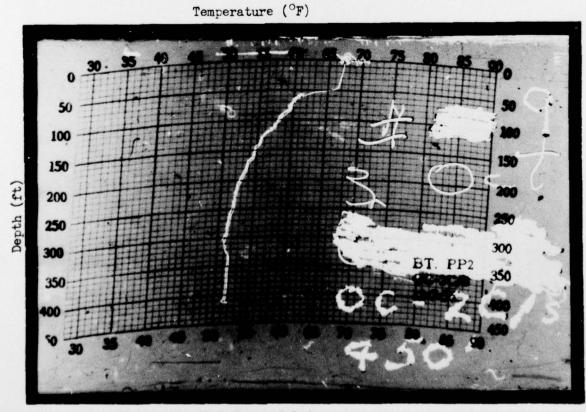
Figure 2. PP-2 Sea trial trace.

The PP-2 grid (fig. 2) is satisfactory; its lines are thin (0.002 inch and less) as a result of underexposure. In the interest of accuracy, it is preferable to err on the thin side rather than the thick, and underexposure is a means to this end. However, the gridmating apparatus should be improved to make thinner lines without underexposure. The names of the grid units should be applied to both axes when there is room.

The depths reached were similar to those of table 1-1 of the instruction book. The PP-2 sample dived as deep as 410 feet at 13 knots with 1100 feet of line out (fig. 2).

The traces of figure 2 have about 0.3°F hysteresis. The trace of decreasing depth is marred by stylus

vibrations excited from the ship, cable, and currents of water around and through the BT. Figure 2 is representative of a BT in good working order.

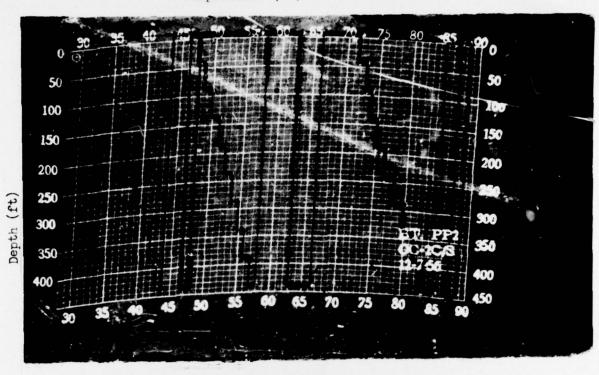
Figure 3. PP-2 Calibration trace

The two tests of the PP-1 produced traces similar to figure 3. Both tests were interrupted by failures of two successive immersion heaters. Figures 4 and 5 show that the temperature and depth errors exceed the specification limits of 1 per cent of full depth and 0.2°F between 34°F and 90°F. The average errors for the two tests vary by 0.3°F and 1.5 feet of water. The stylus probably suffered a change of adjustment between tests. The pen lifter operated at 60 feet as required by the specification.

After the adjustment the calibration was checked from the trace of figure 3 and another trace, and plotted in figure 6. (The slide and grid were not properly aligned when figure 3 was taken.) Test No. 1 was conducted with increasing temperature and Test No. 2 with decreasing temperature. The plot shows the average error after correcting for the 3°F adjustment. The original temperature calibration did not meet the specification because the error varied over a span of 1.2°F between 30° and 90°F. The depth errors were 2 feet and less, meeting the 1 per cent limit of 4.5 feet. The pen lifter operated at 60 feet. Hysteresis data were not obtained during calibration because of the close test scheduling. The sea trials and pressure-element tests give some hysteresis information, and the vertical spread of the points in figure 6 indicates the variation of temperature error for repeated measurements.
